# **Report of Installation on Escalator at Malabon City Square Mall in Manilla Savings of > 25% Payback < 18 Months**

The Malabon Centre is one of the primary shopping facilities within the Malabon District approximately ten miles to the North of Manila.

The installation was on the up-bound escalator from the ground to the first floor and had been chosen for this trial as it was one of the highest use escalators within the facility.

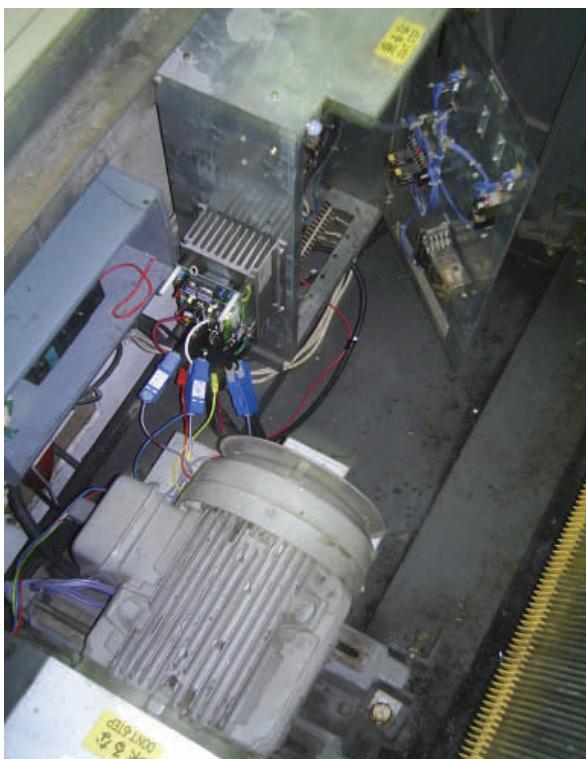
**The Installed Unit at the Top “Pit” of the Escalator**

The existing switchgear was standard Star Delta format contained within top pit of the escalator. EnviroStart, was installed in place of the Star Delta following the line contactor , using an auxiliary normally open contact on the Delta. Forward and Reverse operation were retained in this way as this was another, “must retain” requirement.

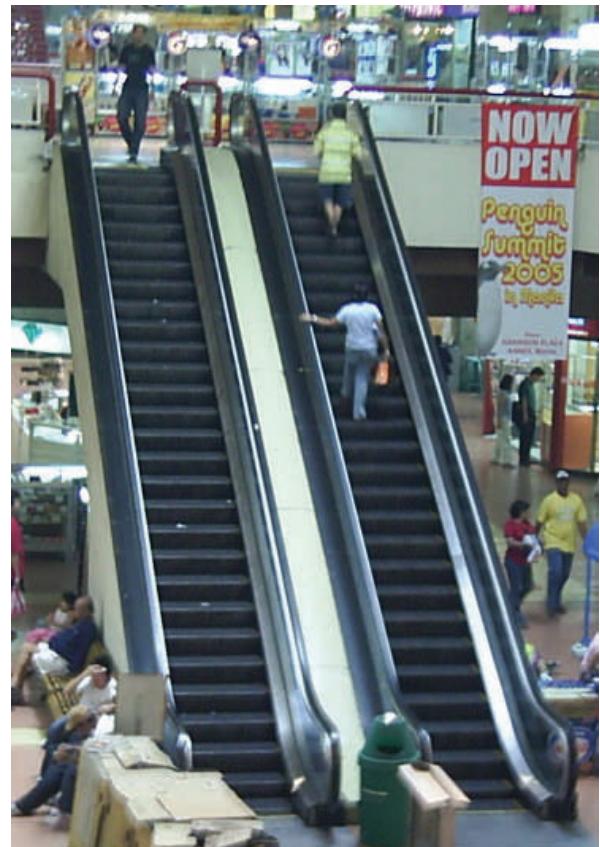
**The Up-Bound Escalator on the Right was Fitted with EnviroStart**

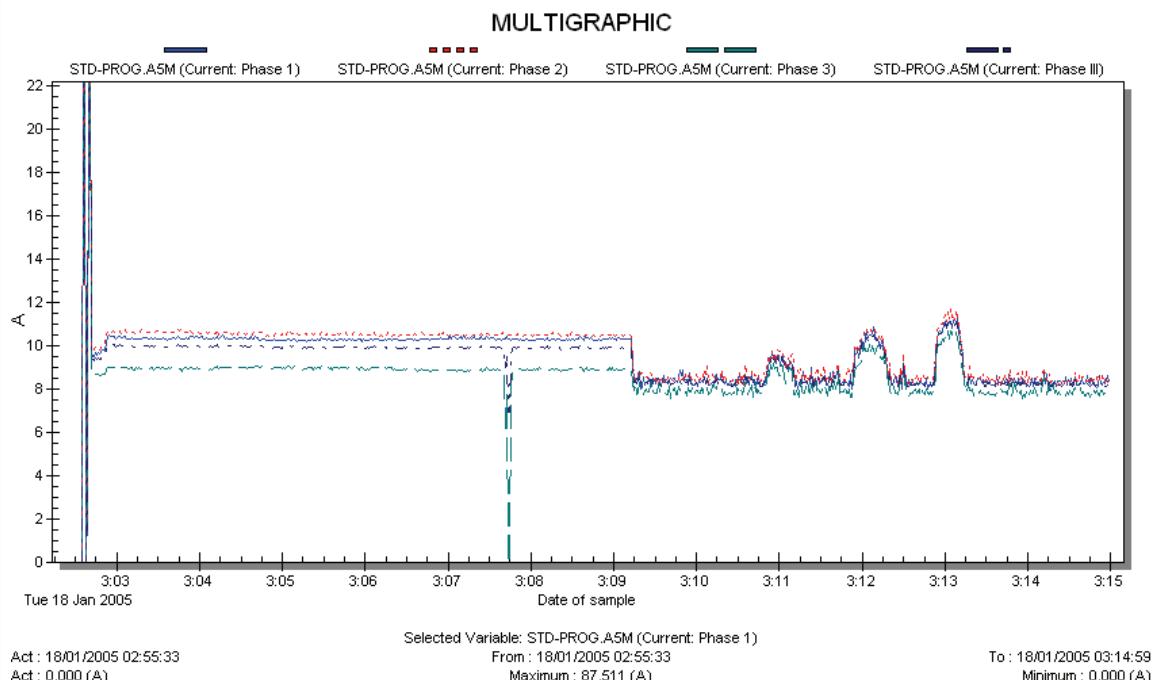
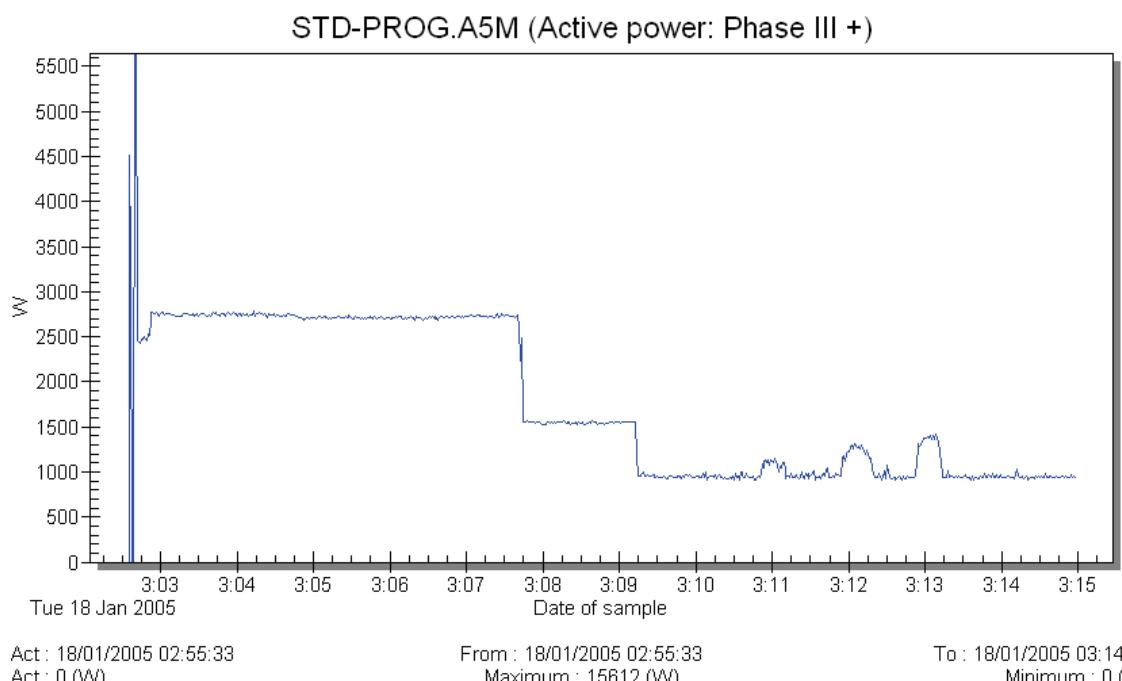
The graphs clearly show the operational savings with EnviroStart in energy saving mode. kW savings of > 25% are consistently achieved.

Once running the escalator was monitored during normal use and it was found that overall savings of >20% were consistently achieved throughout the period of operation.
